INDOOR AIR QUALITY ASSESSMENT

**North Reading Middle School
Sherman Road
North Reading, Massachusetts**

Prepared by:
Massachusetts Department of Public Health
Bureau of Environmental Health Assessment
Emergency Response/Indoor Air Quality Program
January 2004

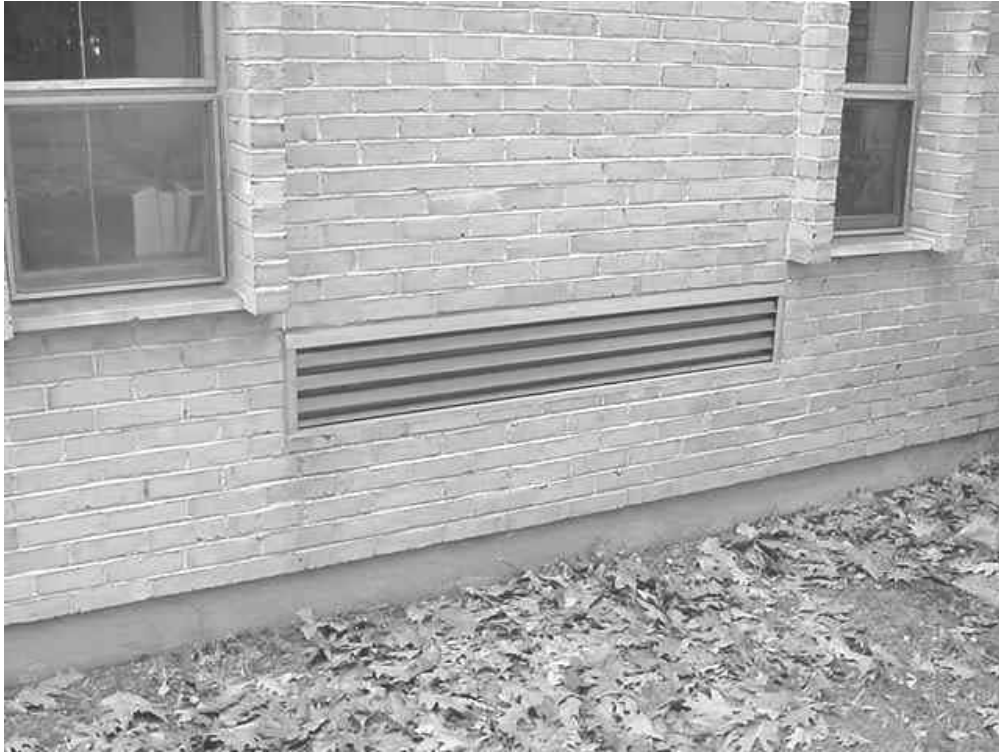
Picture 1

It can be seen from the tables that carbon dioxide levels were elevated above 800 parts per million of air (ppm) in twenty-seven of thirty-nine areas surveyed, indicating inadequate ventilation in a number of areas. Fresh air in classrooms is supplied by a unit ventilator (univent) system. Univents draw air from outdoors through a fresh air intake located on the exterior walls of the building (Picture 1) and return air through an air intake located at the base of each unit ([Figure 1](#)). Fresh and return air are mixed, filtered, heated and provided to classrooms through an air diffuser located in the top of the unit. The majority of univents were operating during the assessment. Univents are reported by Mr. Hardacker to be original equipment, which have been serviced and have had parts replaced through the years. Obstructions to airflow, such as papers and books stored on univents and items in front of univent returns were seen in a number of classrooms (Picture 2). In order for univents to provide fresh air as designed, intakes must remain free of obstructions.

Univent Fresh Air Intake

1. Survey classroom univents to ascertain function and determine whether an adequate air supply exists for each room. Consider consulting a heating, ventilation and air conditioning (HVAC) engineer concerning the calibration of univent fresh air control dampers throughout the school.

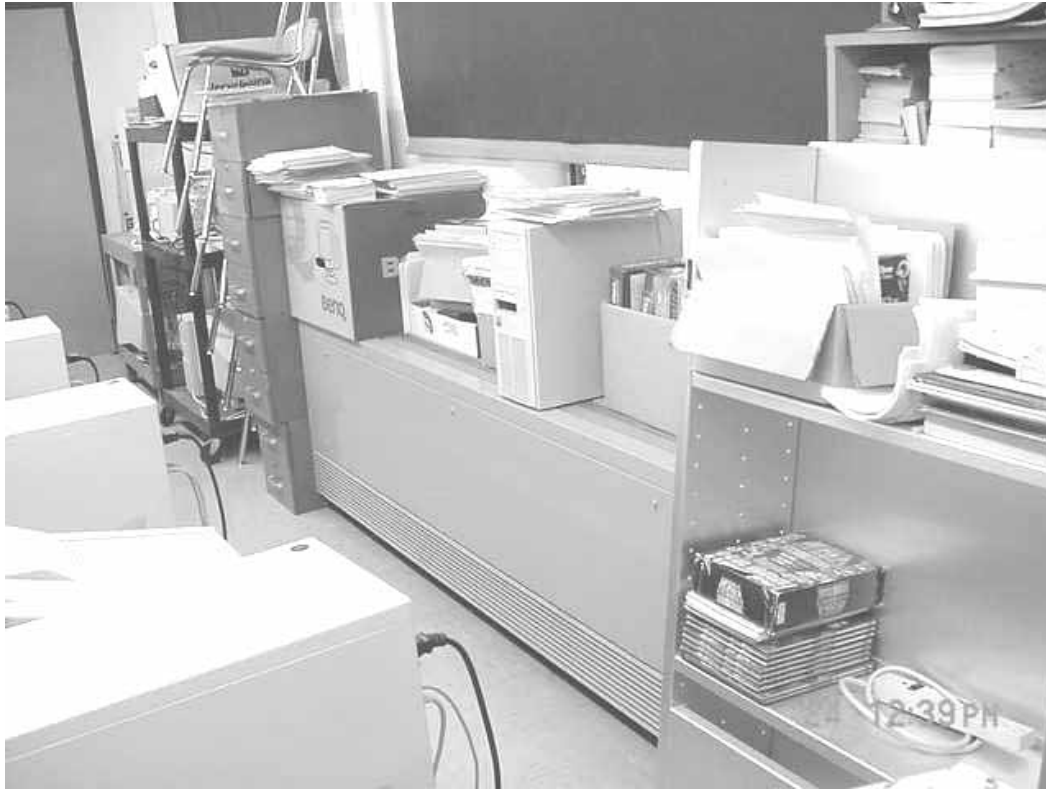
Picture 2

Items Obstructing Univent Air Diffuser

3. Inspect rooftop exhaust motors and belts for proper function, repair and replace as necessary.
4. Remove all blockages from univents and exhaust vents.

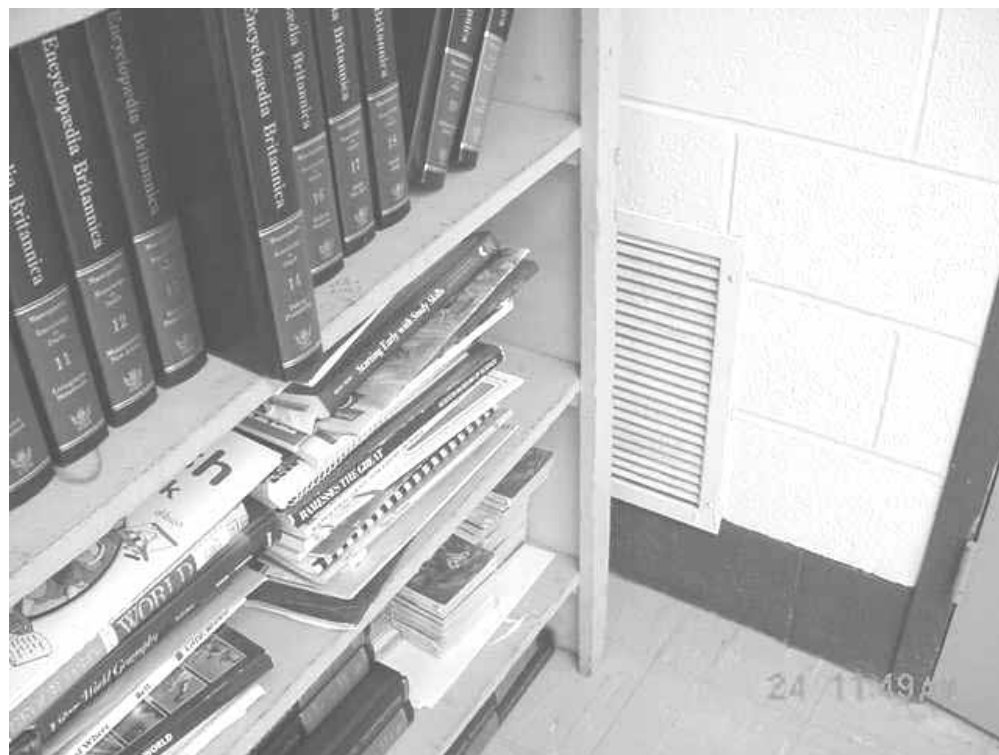
Picture 3

Exhaust ventilation in classrooms consists of wall-mounted vents powered by rooftop motors. The exhaust system was not drawing and/or backdrafting in a number of areas surveyed, indicating that motors were deactivated or non-functional. Without adequate exhaust ventilation, excess heat and environmental pollutants can build up and lead to indoor air complaints. Items were also seen obstructing exhaust vents in classrooms (Picture 3). As with the univents, exhaust vents must remain free of obstructions to function as designed.

Exhaust Vent Obstructed by Bookcase

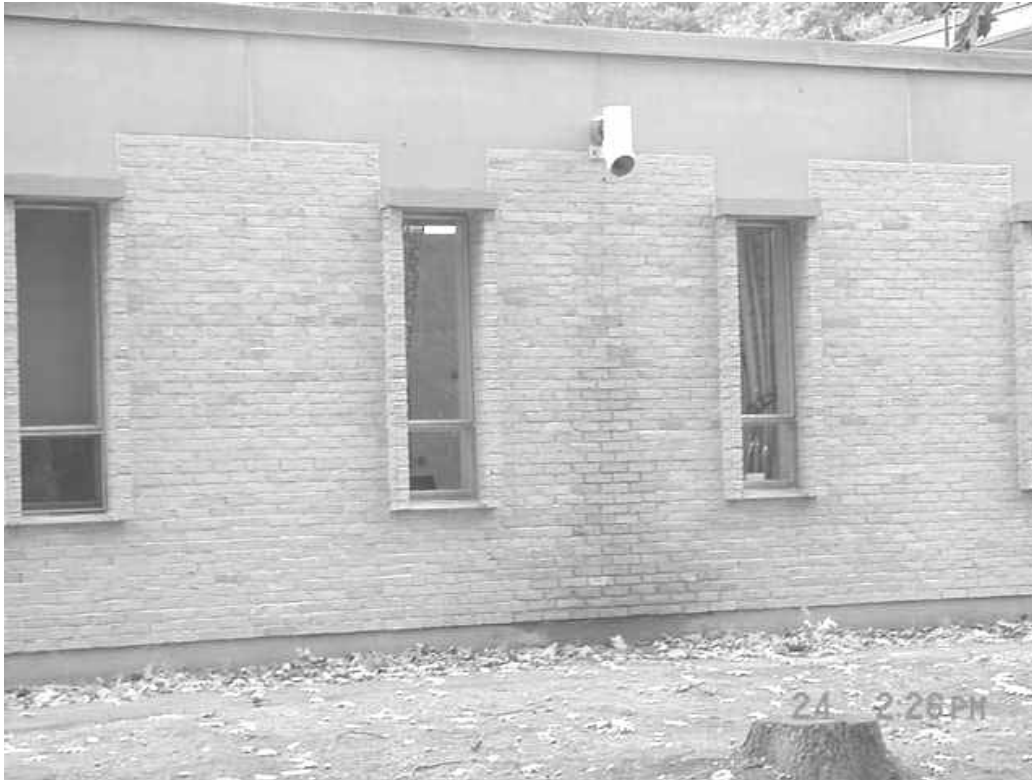
Picture 4

Roof drains are connected to PVC pipe that empties water against the side of the building (Picture 4), leaving characteristic stains on the exterior brick. Gutters and downspouts are designed to collect and divert rainwater away from the building. In their current condition, water can flow down and pool against the building, which leads to potential water damage.

Roof Drain Emptying against the Building

8. Continue with plans to replace windows throughout the school.
9. Install downspouts with elbow extensions to drain water away from the building.
10. Examine the feasibility of installing local exhaust ventilation in the teacher’s workroom.

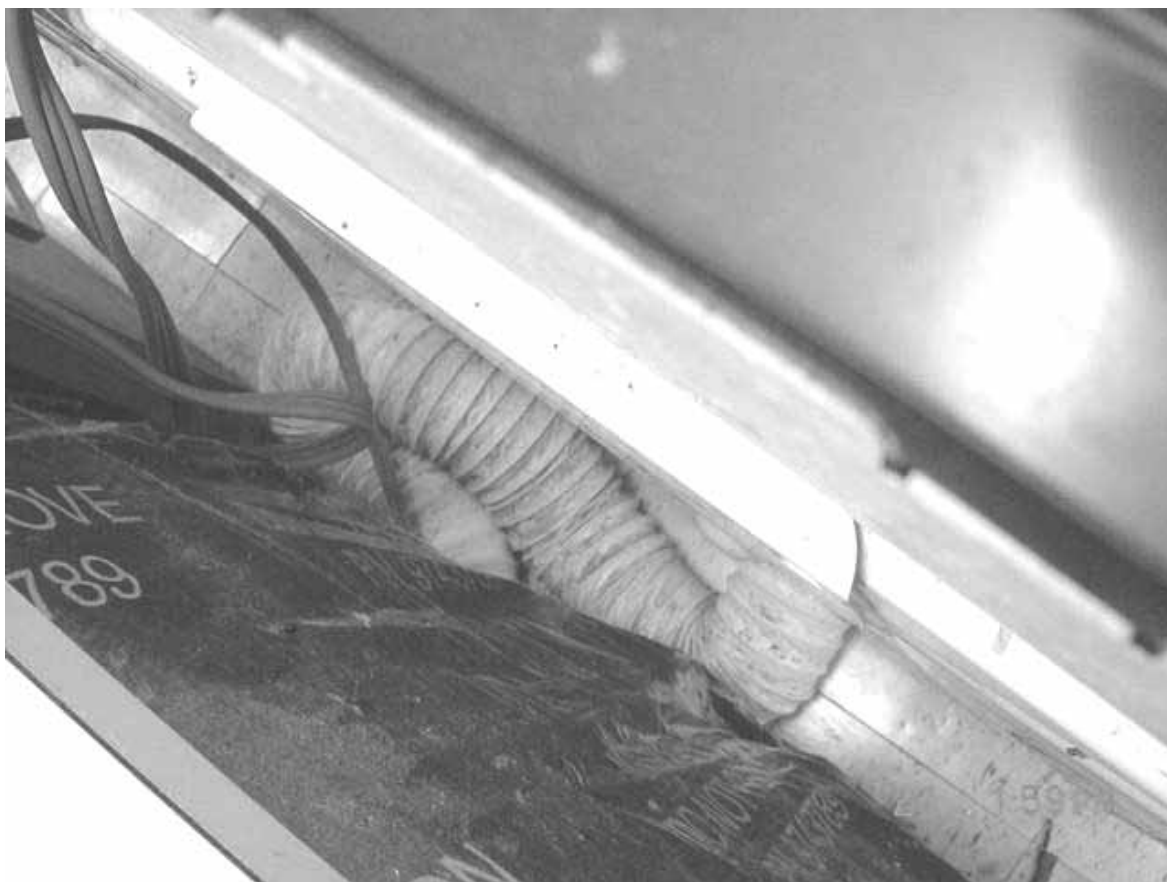
Picture 5

Classroom B8-A contained a clothes dryer. BEHA staff inspected the dryer to see if it was properly vented and found the flexible exhaust duct was kinked, preventing proper airflow (Picture 5). Dryers must be properly vented to remove excess heat, moisture and particulates.

“Kinked” Flexible Dryer Vent in Classroom B8-A

11. Reduce length of flexible dryer exhaust to facilitate airflow.
